Tree Risk Assessment

Menheniot Playing Field & Merrymeet Communal Area

Reference: 2406-3 TRA (2023)

Report Date: 26.01.2023

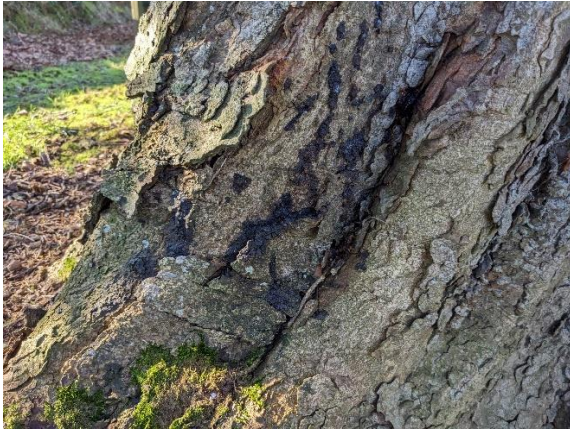
Horse Chestnut (3954)

- 8.8 The easterly most chestnut (T3954) is still displaying signs of sapwood dysfunction referred to in previous reports. This includes some small stem lesions, exudation, and a small area of slime flux. The tree is sheltered from prevailing winds and occupancy rates within the target area (towards the north-east) are reasonably low.

In the unlikely event of failure, this would likely occur during strong winds when occupancy levels would be very low. The risk posed by the tree is therefore tolerable.

G1	Oak, birch, lawson cypress, beech	7-12	100-600	4	4	4	4	2	SM	B2	No action required.	40	Good
Merrymeet													
T3953	Sessile Oak (QuPe)	10 (2)	600 (1)	2	5	4	4	2	SM	B1	Major deadwood as noted on last survey is still there. Asymmetrical crown due to overshadowing.	40+	Fair
T3954	Horse Chestnut (AeHi)	10 (2)	700 (1)	4	4	4	4	2	SM	B1	Black exudate on stem remains - see photos. Long scar tissue from ground to 3m is occluding. Monitor annually.	40+	Fair

I advise that informal inspections are carried out by PC staff as they go about their normal duties and take note of any obvious changes or failure that would be obvious to an informed but non expert person. A formal inspection should occur again in two years' time. If informal inspections are not practicable, then a formal inspection should occur in 1 years' time.

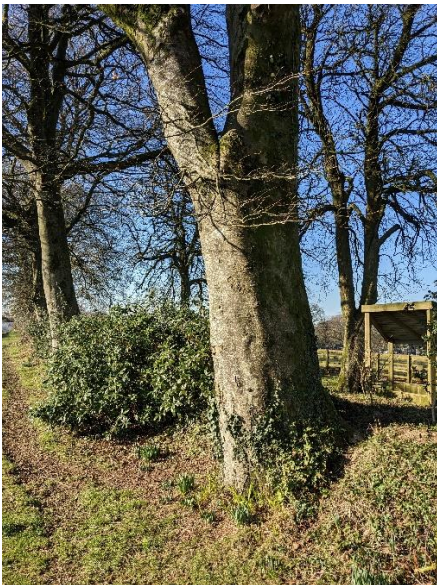
T3956	Beech (FaSy)	20 (2)	600 (1)	4	6	6	6	3	EM	B1	<p>Primary branch south side at 4m has included bark present on east side. Defect does somewhat increase the likelihood of failure, which would cause it to fall onto the road. The defective side of the fork is situated opposite the prevailing winds and the road has relatively low levels of use. As such the defect does not warrant action on grounds of safety.</p> <p>QTRA</p> <p>Occupancy 3 x Size 3 x PoF 5 = 1/1M Risk of Harm (Broadly acceptable).</p> <p>Failure of the branch is not likely because the defective part is sheltered from prevailing winds. It is more vulnerable to easterly gales, which are not common. Failure would be arboriculturally significant due to the size of the wound it would leave. Included in Appendix E is a picture of the tree with a suggested crown reduction which would significantly reduce the likelihood of failure. This can be implemented as a management recommendation at your discretion.</p>	40+	Fair

Beech (3956) fork east side.

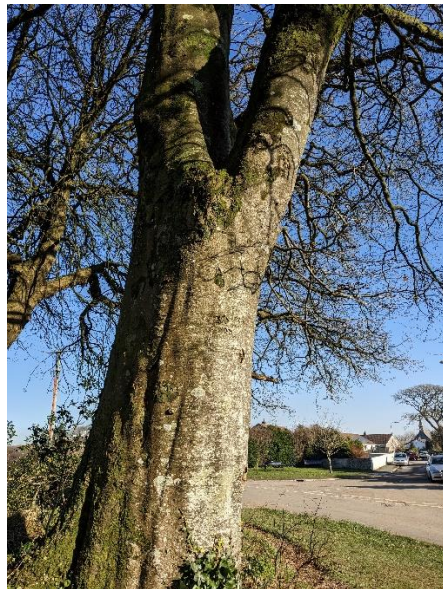
Beech (3956) fork west side.

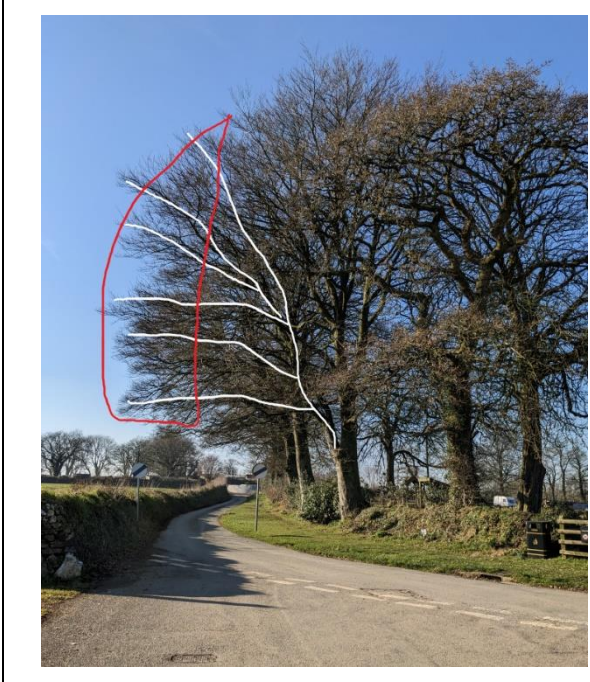
Beech (3956).

The white lines show the approximate tracery of the branch affected. The red line gives an indication of the amount of crown to be removed.

- 9.1 No works are necessary to mitigate risks.
- 9.2 Generally, the sites should be inspected again in 2025, sooner if sudden changes are observed in a tree or trees or the area around them. This inspection should be undertaken by a qualified arboriculturist.
- 9.3 The PC ought to ensure that informal inspections are carried out on an ongoing basis by staff responsible for managing or maintaining the grounds. They would do so as they go about their day-to-day routine and make themselves aware of the trees general health and condition. They would identify structural weakness or actual failure that pose an imminent threat to people or property that would be patently apparent to a non-expert.
- 9.4 Works are suggested to the beech tree 3956, which are being advised for management reasons rather than risk.
